PAVEMENT CAUSED FOD TO AIRCRAFT ENGINES

ABSTRACT

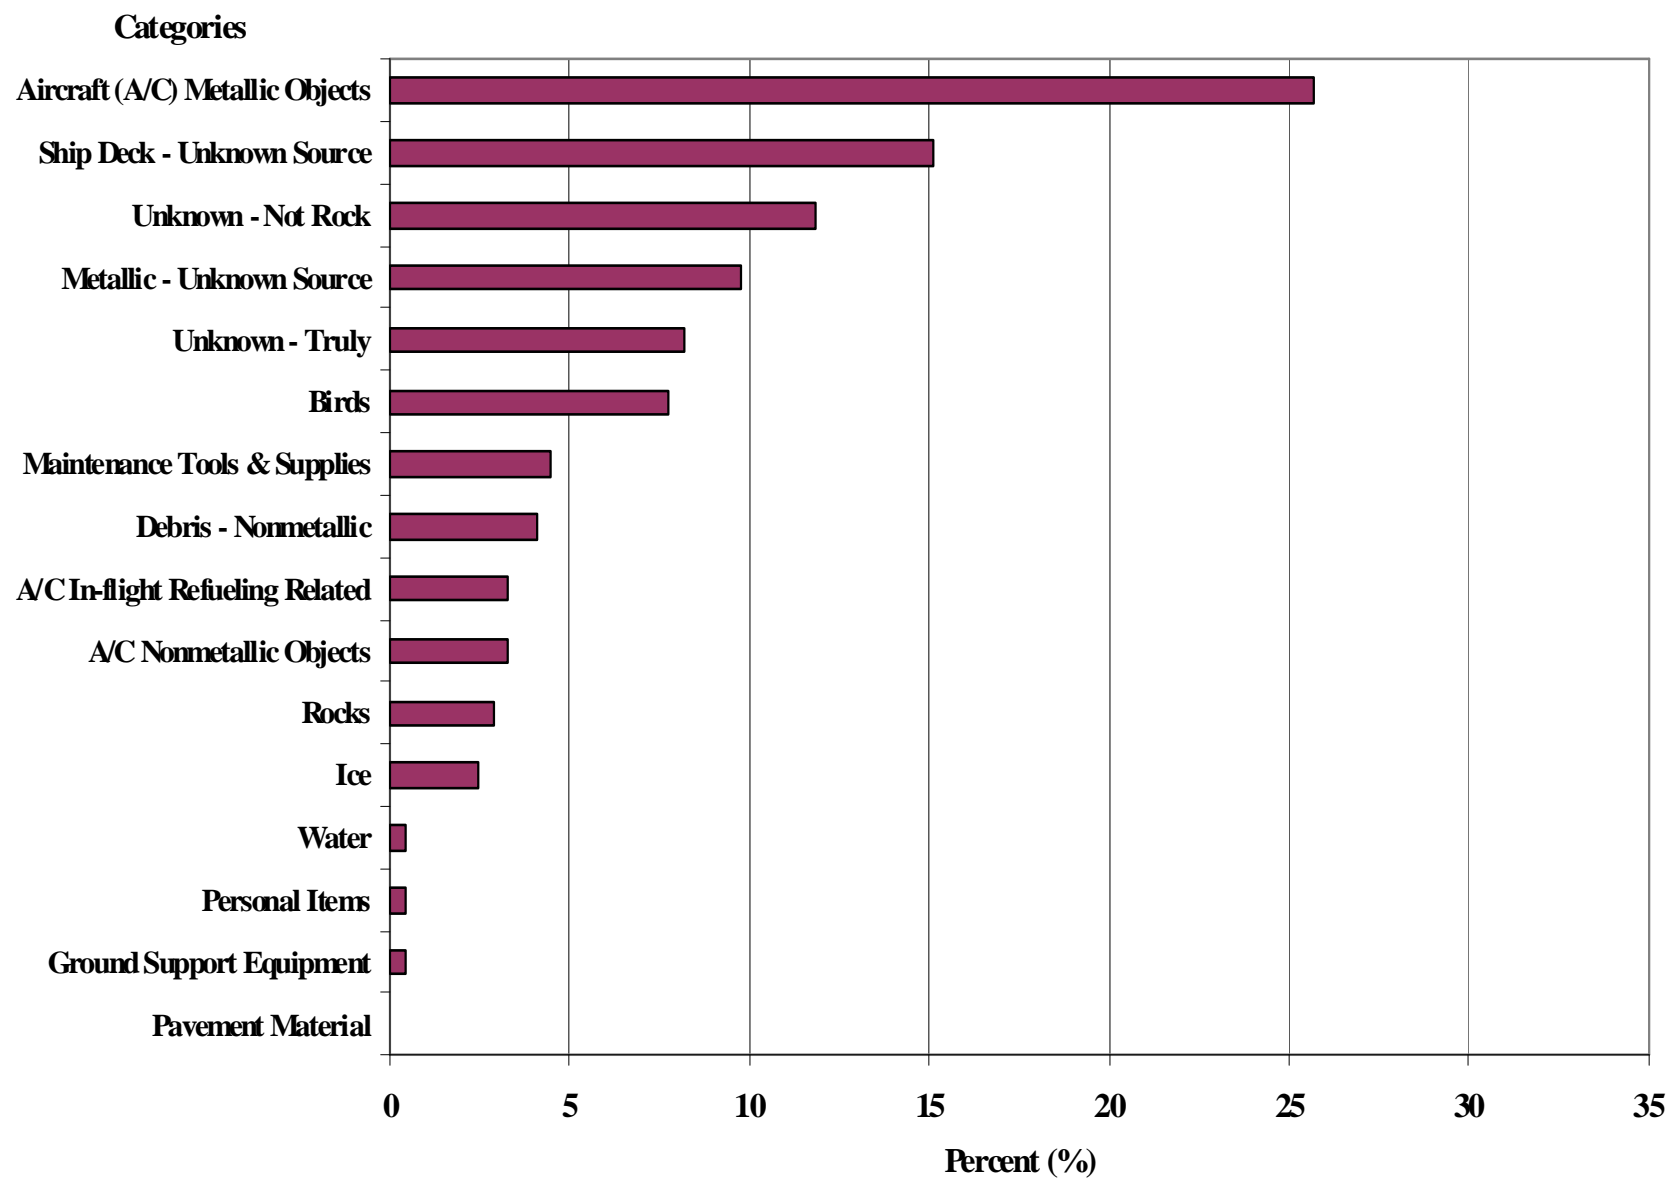
FIGURE 7 FOD incidents - All COMNAVAIRLANT data.

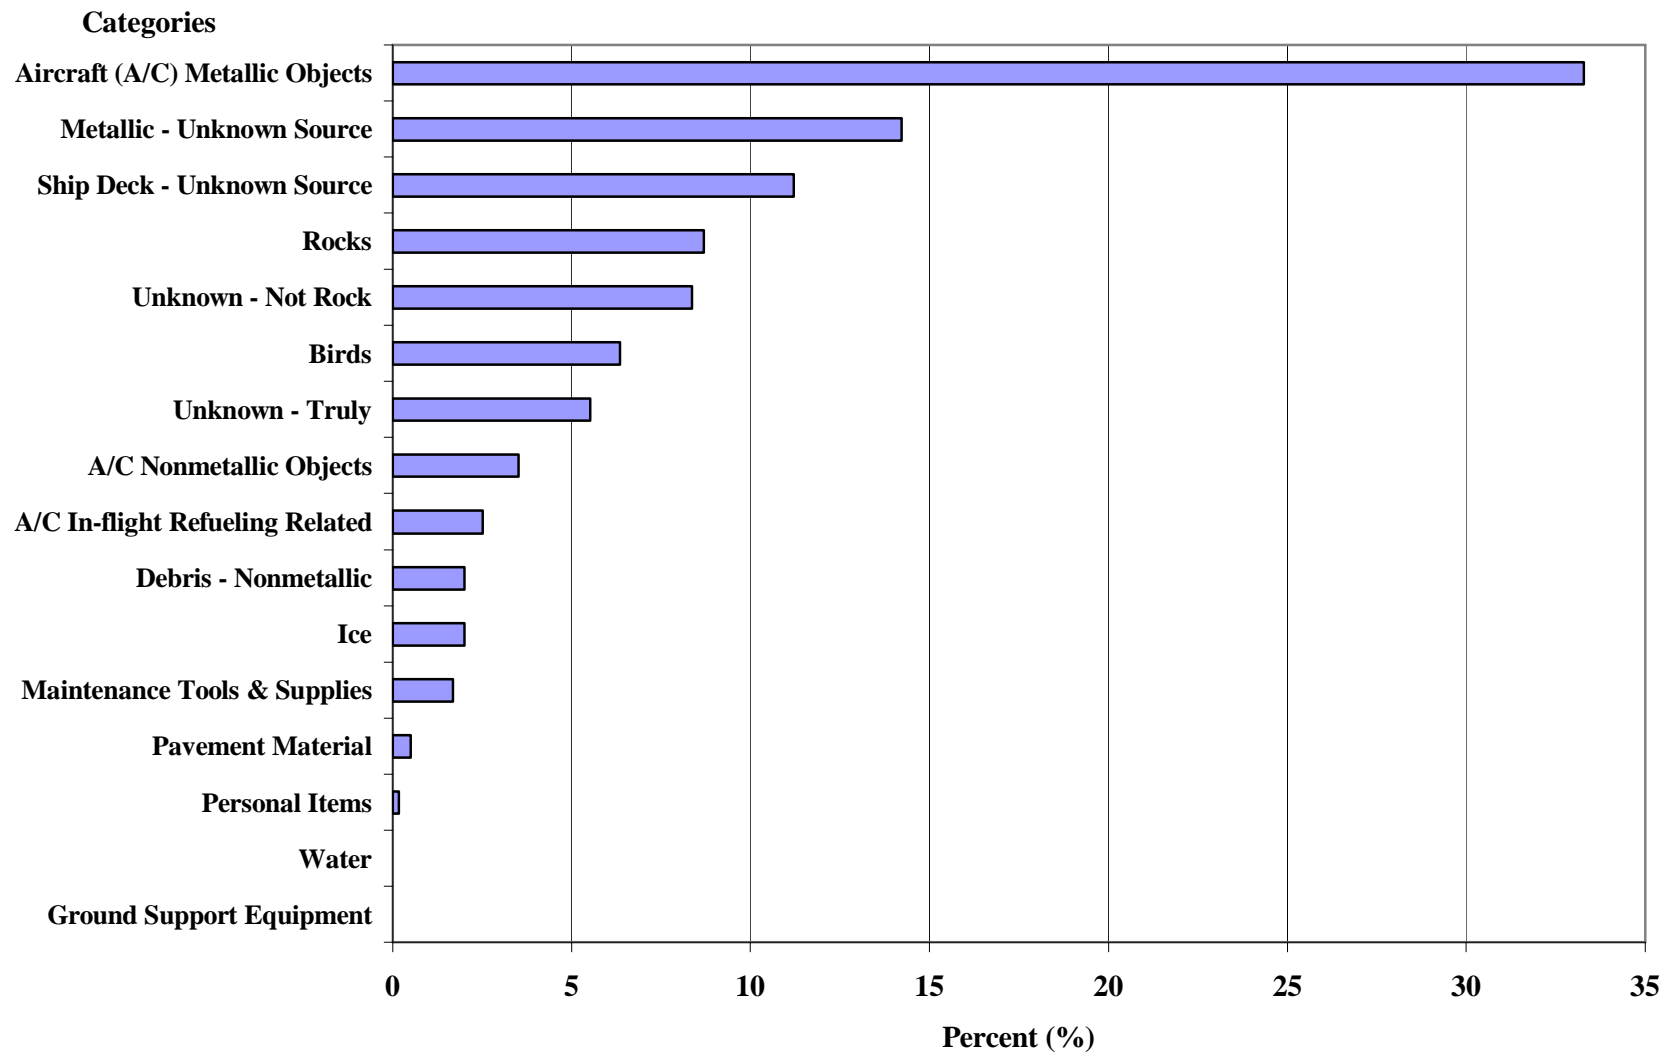
FIGURE 8 FOD incidents - All COMNAVAIRPAC data.

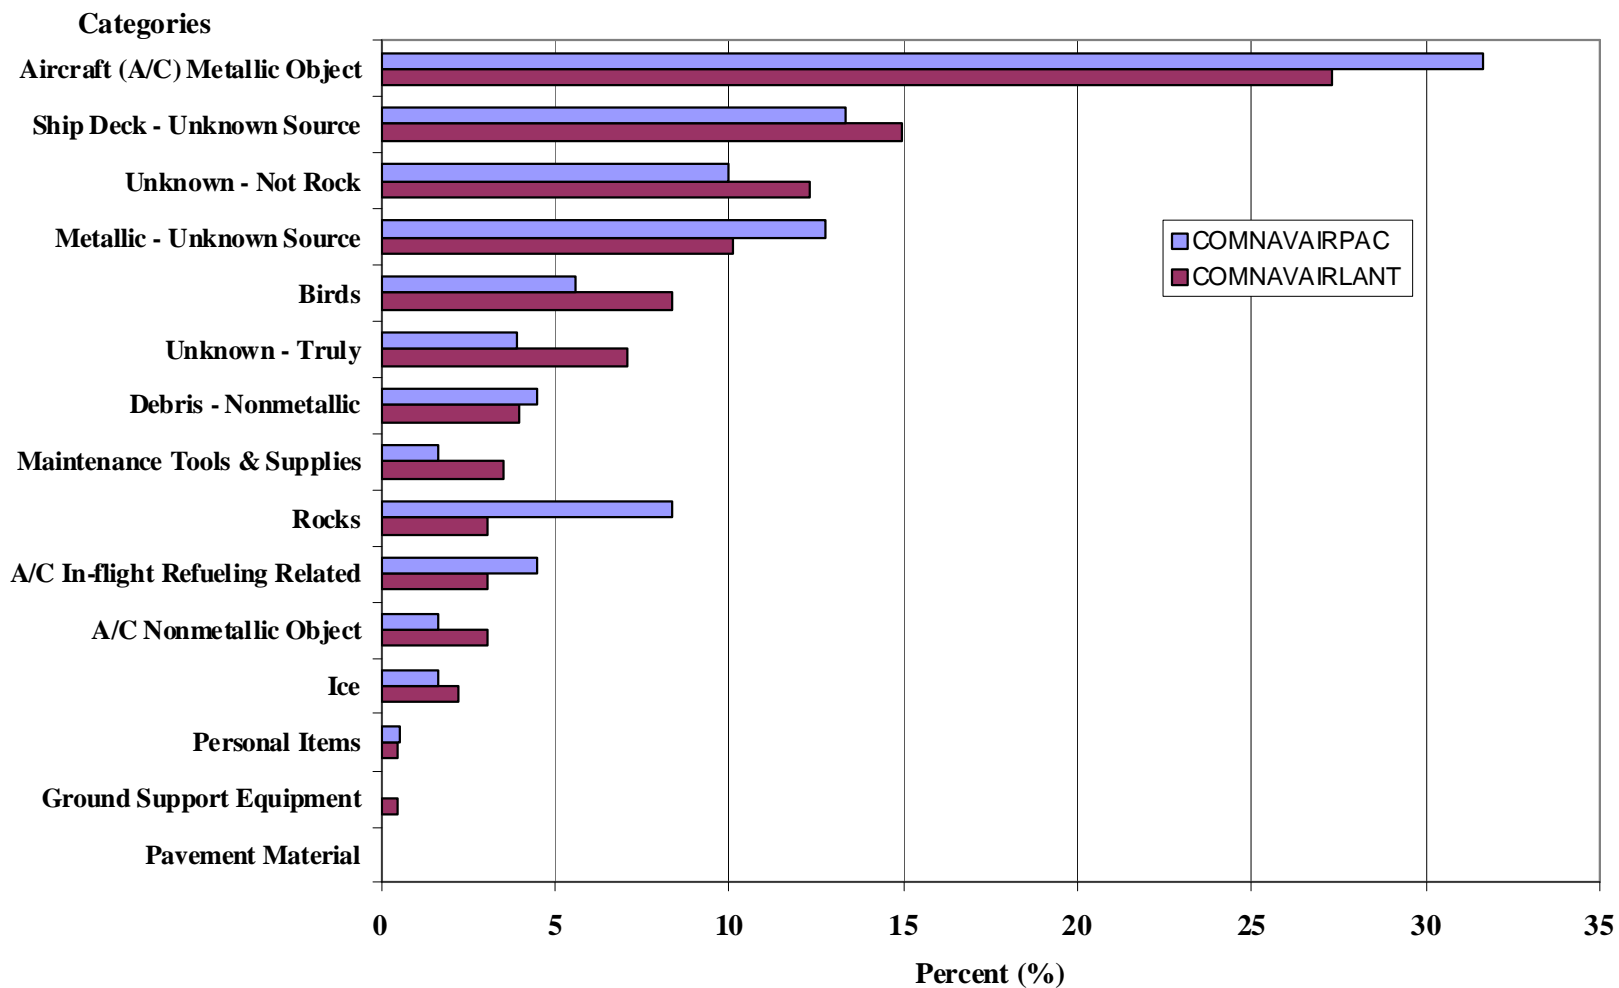
The results of the analyses incorporating the data over the common time frame of January 2002 through March 2003 are shown in Table 1 and summarized in Figure 9. In Table 1, it can be seen that metallic objects originating from the aircraft itself is the cause of a large portion of the FOD incidences. The second leading cause of engine damage is by FOD ingested while on shipboard, where pavement debris is not present. Figure 9 shows a comparison between the FOD incidences experienced by aircraft operators in COMNAVIAIRLANT and COMNAVIAIRPAC activities during this common time period. It can be seen in this figure that the distribution of the causes could be considered statistically the same for both Commands. One difference worthy of note is "rocks" where COMNAVIAIRPAC activities experienced twice as much as COMNAVIAIRLANT activities. This difference is discussed in further detail later in this paper.

FIGURE 9 FOD incidents – COMNAVAIRLANT and COMNAVAIRPAC data for January 2002 through March 2003.

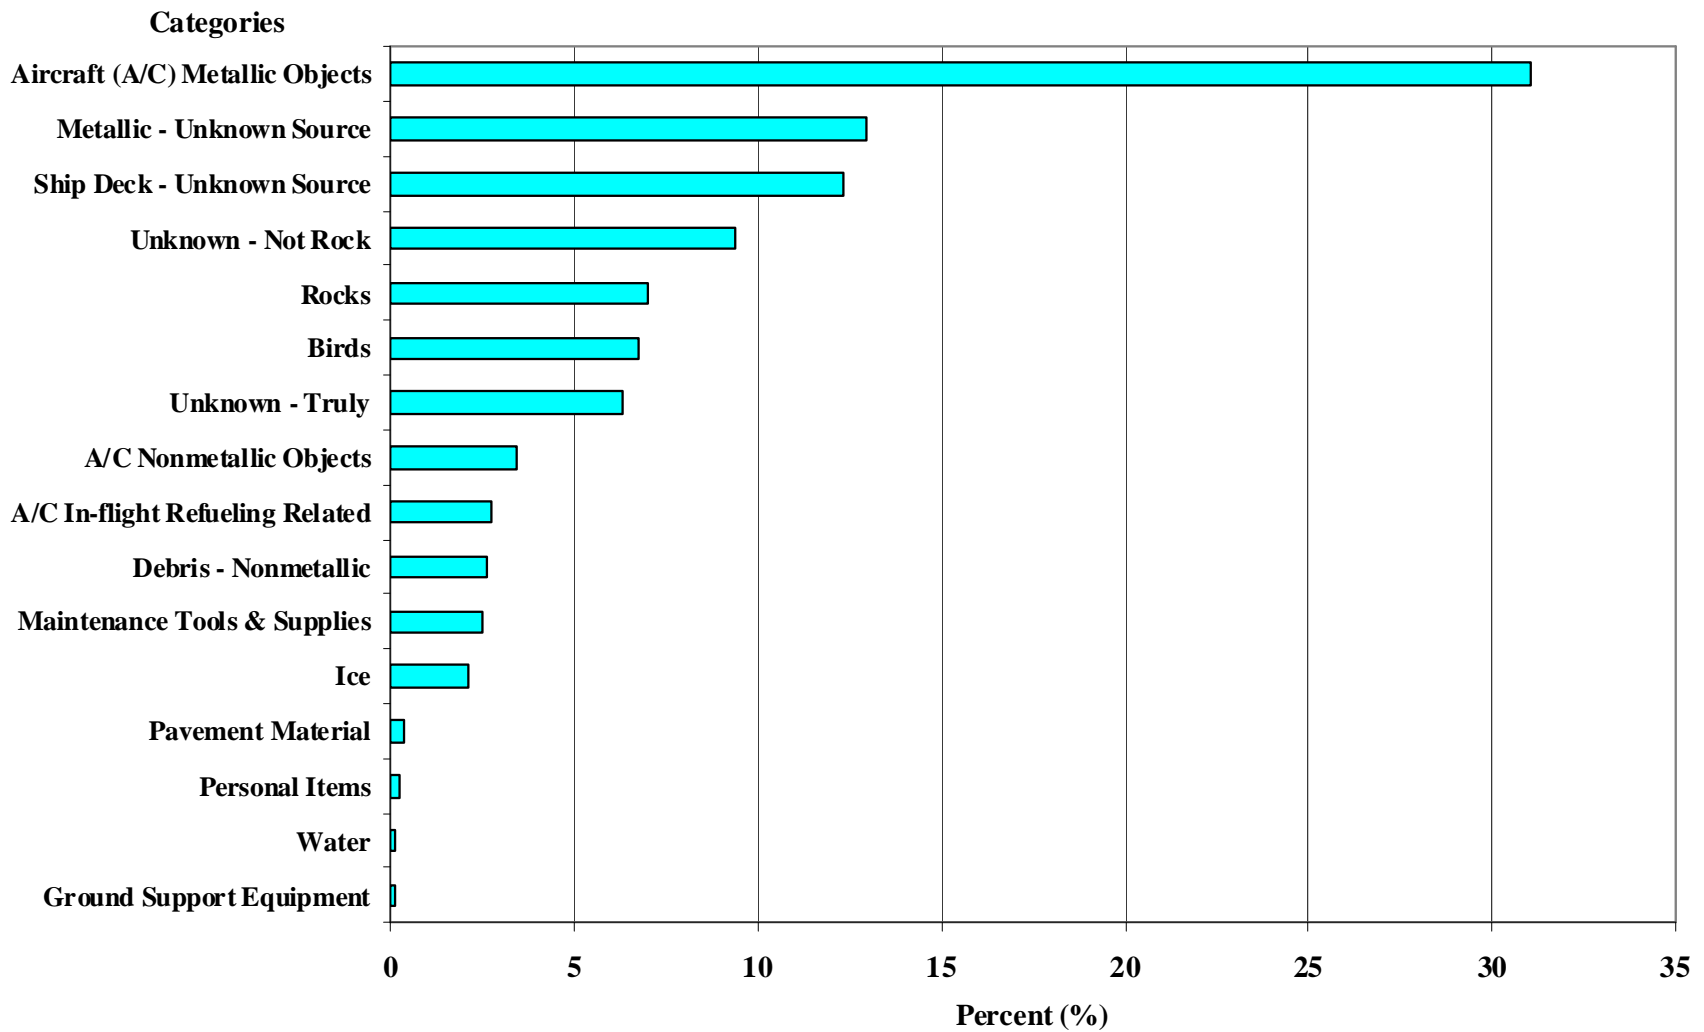
The results of the analyses incorporating all of the data collected are shown in Table 2 and Figure 10. In Table 2, it can be seen that metallic objects are responsible for 44% of the damaged engines. There is a good possibility that metal objects could also be involved in the damaged engines assigned to the categories of "Ship deck – Unknown Source" and "Unknown - Not Rock." The category of "Rocks" was responsible for 7% of the damaged engines and "Pavement Material" for 0.4%.

FIGURE 10 FOD incidents – all collected data combined.
